THE 2011 ZEN GARDEN LANDSLIDES: TRIGGER AND CAUSAL FACTORS

ABSTRACT: *The Zen Garden Resort and its surrounding area are part of the “Kundasang Landslide Complex” and were experiencing reactivation of old landslides on 10 April 2011. Consequently, more than 80 room units of the resort, ten buildings, homes, and local roads were destroyed, uplifted, and damaged as well as disrupted day traffic. About 500m in length and 200m in width of the slope area were slides for 25m. The vertical fall movement in the head section of the landslide is 25m. There is no direct relationship between the 2015 Ranau earthquake and with earlier rotational clay slide of the 2011 Zen Garden Resort landslide. The causing and triggering factor for landslides are generally varied and are always characterized as region-specific and site-specific. Thus, this study was conducted to unravel the triggering and causal factors for the rotational clay slide of the 2011 Zen Garden Resort landslide. The methodology consists of desk study, remote sensing study, geological mapping, geodynamic mapping, laboratory, and data analysis. This study found that the landslides were triggered by prolonged moderate to occasional h

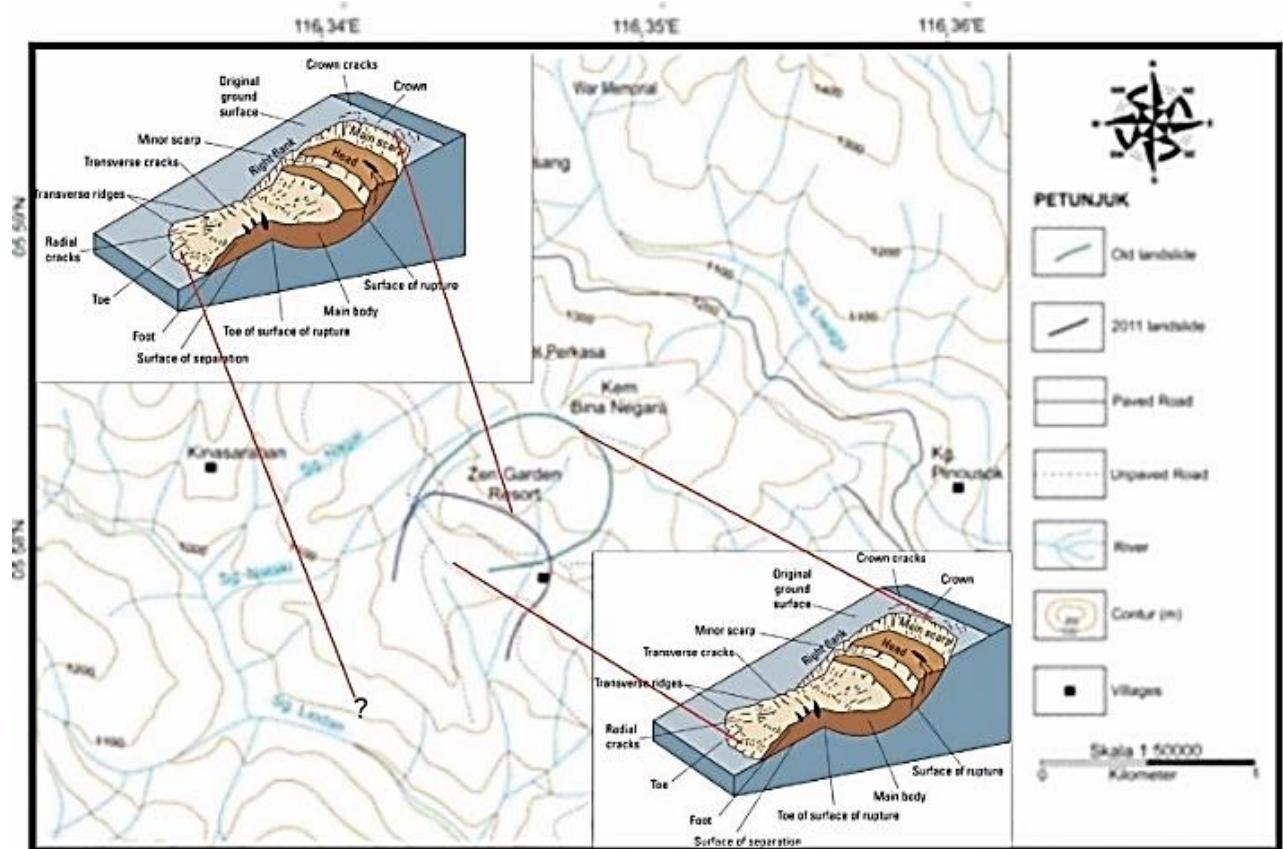
Typical landslide morphology is shown in Figure 3 which is divided into head, body, foot, and toe sections. This landslide is the reactivation of an old dormant landslide (Figure 3) and classified as a rotational clay slide (Hunger et al., 2014). The movement was involving a rotational slide. The materials are colluvium deposits which come from the old landslide and are dominated by matrix material. Then, the slope materials are classified as clay.

Figure 3 Location and the reactivation on the body (transverse crack) of old landslides. Upper left- old landslide morphology; Lower right- rotational clay slide of the Zen Garden 2011.

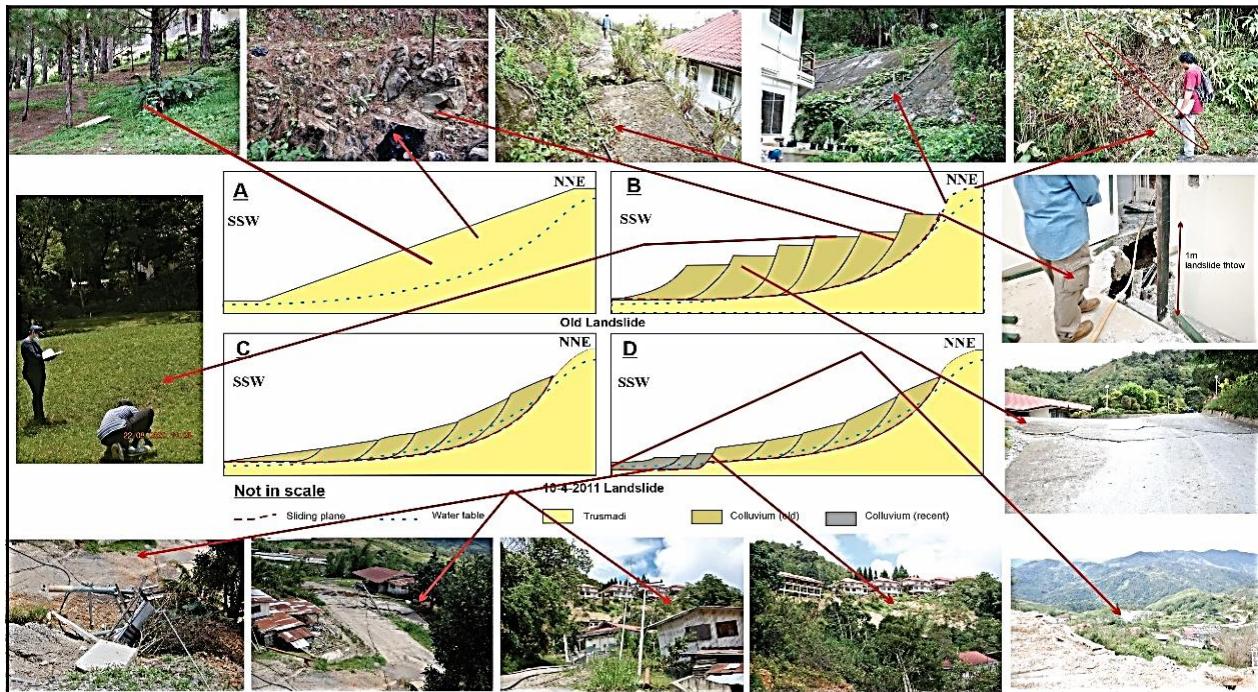
Figure 4 shows the chronology of the formation of a rotational clay slide of the 2011 Zen Garden Resort landslide:

A. Natural slope and water table in the Zen Garden Resort area. The slope has been undergoing natural slope equilibrium processes.

B. The morphology of the old Zen Garden landslide but the upper boundary is not found in field investigation and remote sensing study. Interview with surrounding local was made to collect the data. The transverse crack, major and minor scarp, tension crack, 1m down-thrown surface level, undulating resort road, and colluvium deposit of the old landslide are shown in the Photos in Figure 4.

C. Weathering and erosional processes on the slope surface produce smoother slopes but raise the water table. Surface levelling and fertility of secondary plant shows the natural erosional activity, infiltration, and existence of colluvium deposits from an old landslide.

D. After 20 years, the slope becomes smoother due to the natural phenomenon of slope equilibrium. The slide comes once again but moves its position towards the southern part of the study area. The rotational clay slide of the 2011 Zen Garden Resort landslide took place on the transverse crack of the body section of the old dorman landslide. This landslide is caused by about 200 m width, 450 m length, more than 20 m vertical fall, and tens of meter area thrown down the slope as well as the destruction of more than 80 room units, damages of few buildings, roads, homes and a day traffic disruption. The main scarp, tension crack, transverse crack and foot section are clearly shown in the attached Photos in Figure 4.

Figure 4 The rotational clay slide of the 2011 Zen Garden Resort Landslide model and the reactivation on the body (transverse crack) of old landslides with attached photos for the selected landslide section. A- Natural slope surface; B- Old landslide mechanism; C- towards natural slope equilibrium; D- rotational clay slide of the 2011 Zen Garden landslide.

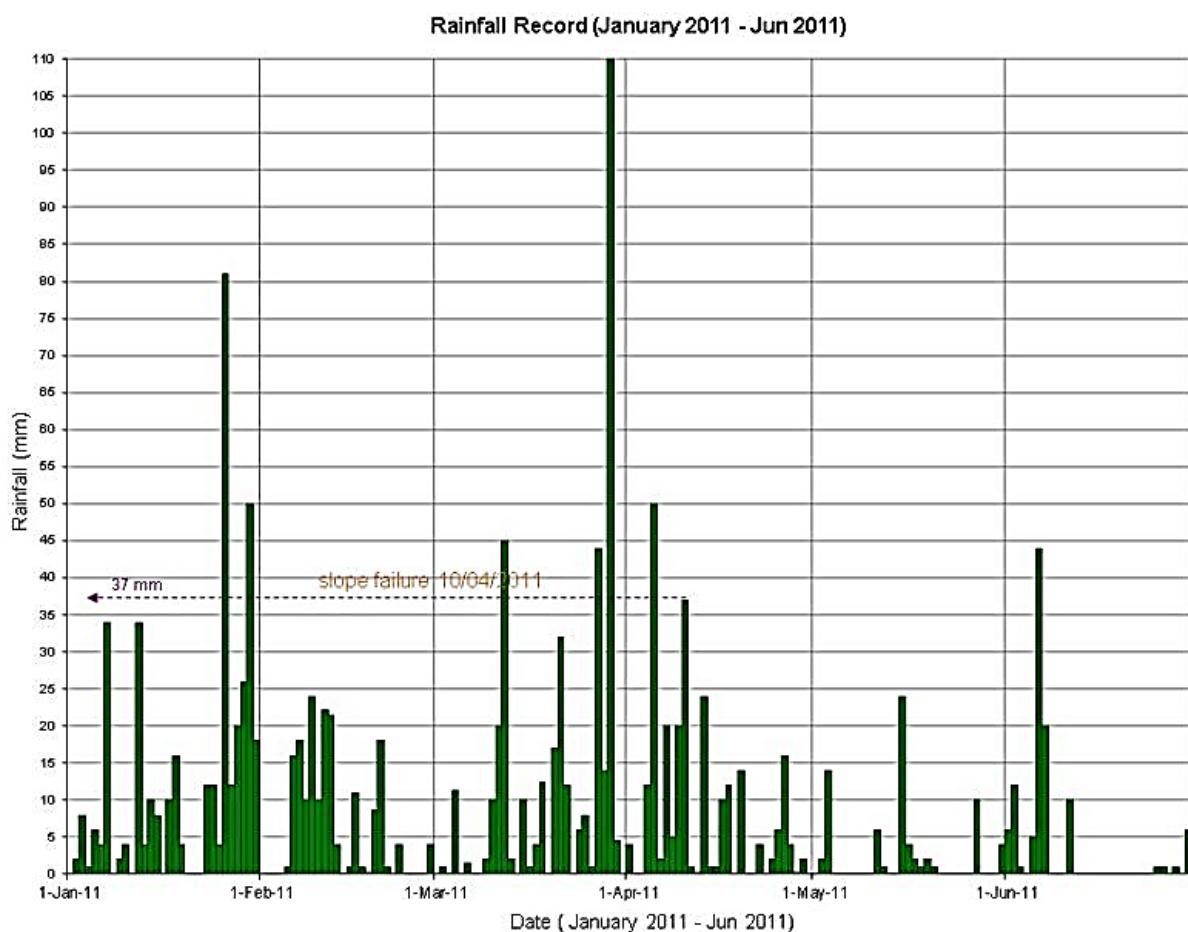
The annual rainfall for the Kundasang area is 2440 mm on average and experienced prolonged light rain type (5-20 mm/day) or moderate with occasional heavy rainfall from January to June 2011. The landslides on 10 April 2011 occurred in only 37mm of rainfall but occasional intense rainfall (until 110 mm/day) happened before (Figure 5). That prolonged moderate to occasional heavy rainfall will raise groundwater level rapidly condition to the ground surface and this would result in a sudden increase in pore pressure which would reduce the shearing resistance of geomaterial and finally lead to a failure or landslide.

Figure 5 Daily rainfall record from January to June 2011 in the Kundasang area (source from IKRAM, 2011).

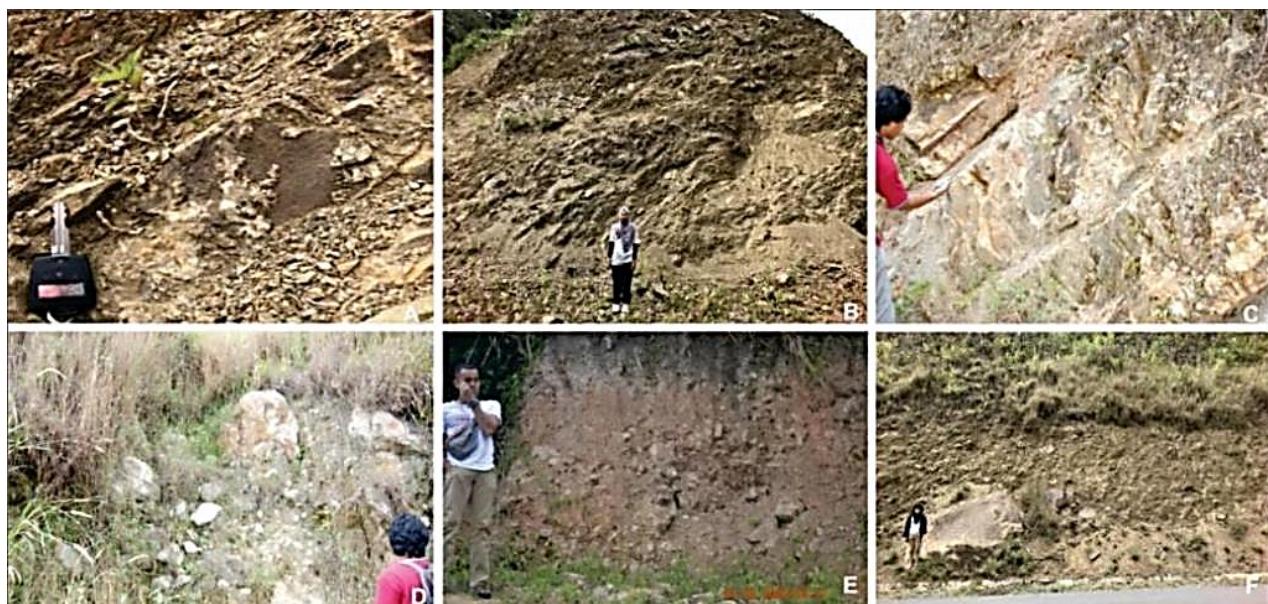
There are four (4) rocks unit underlying the study area namely Trusmadi formation, Crocker formation, Pinosuk Gravel, and Colluvium deposit (alluvium) (Photo 1). Laboratory analysis found

that the Colluvium deposit is weak (19.52 MPa) by Lithological Unit Thickness, LUT method (Ismail Abd Rahim et al., 2009). The characteristics of Pinosuk Gravel which is almost like Colluvium (i.e., unconsolidated deposit and consists of rock block and matrix materials) assumed as a 'weak' rock unit also. The Uniaxial Compressive Test (UCT) was conducted on Trusmadi and Crocker formations rocks and found the strength to be medium (Table 2). Then, it concludes that the strength of rock units varies from 'medium to weak' and is prone to landslides or less resisting force.

Photo 1 Moderately strong to weak rock units' appearance. A& B- Sheared meta-arenite and meta-argillite (dark) of Trusmadi formation; C- Crocker formation sandstone; D- Pinosuk Gravel; E&F- colluvium deposits.

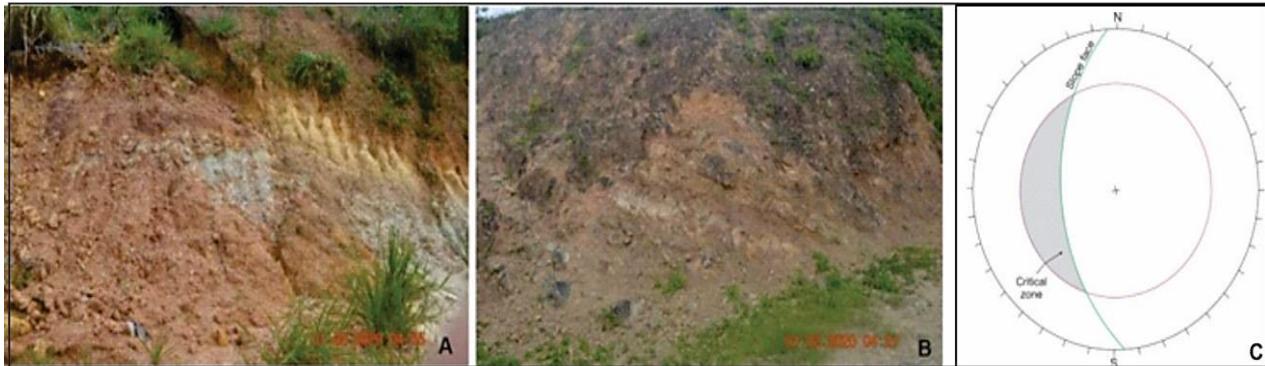
In the weathering process especially for class IV, the old discontinuity plane normally disappears. So, the discontinuity observation during the survey depends on relic structures on the limited outcrop. The effect of the weathering activity on discontinuities is the formation of planar failure in the Markland test (Figure 7C). Highly weathered Trusmadi formations (underlain Zen Garden Resort) are locally potential to produce a high concentration of kaolinite and illite. This clay easily absorbs water and expands. Then, facilitate mass movement by reducing the resisting force in slope-forming rock materials, especially during heavy or prolonged rainfall (Baba Musta, 2021).

Figure 7 The weathered (class IV) rock unit. A- Crocker formation; B- Trusmadi formation; C- planar failure.

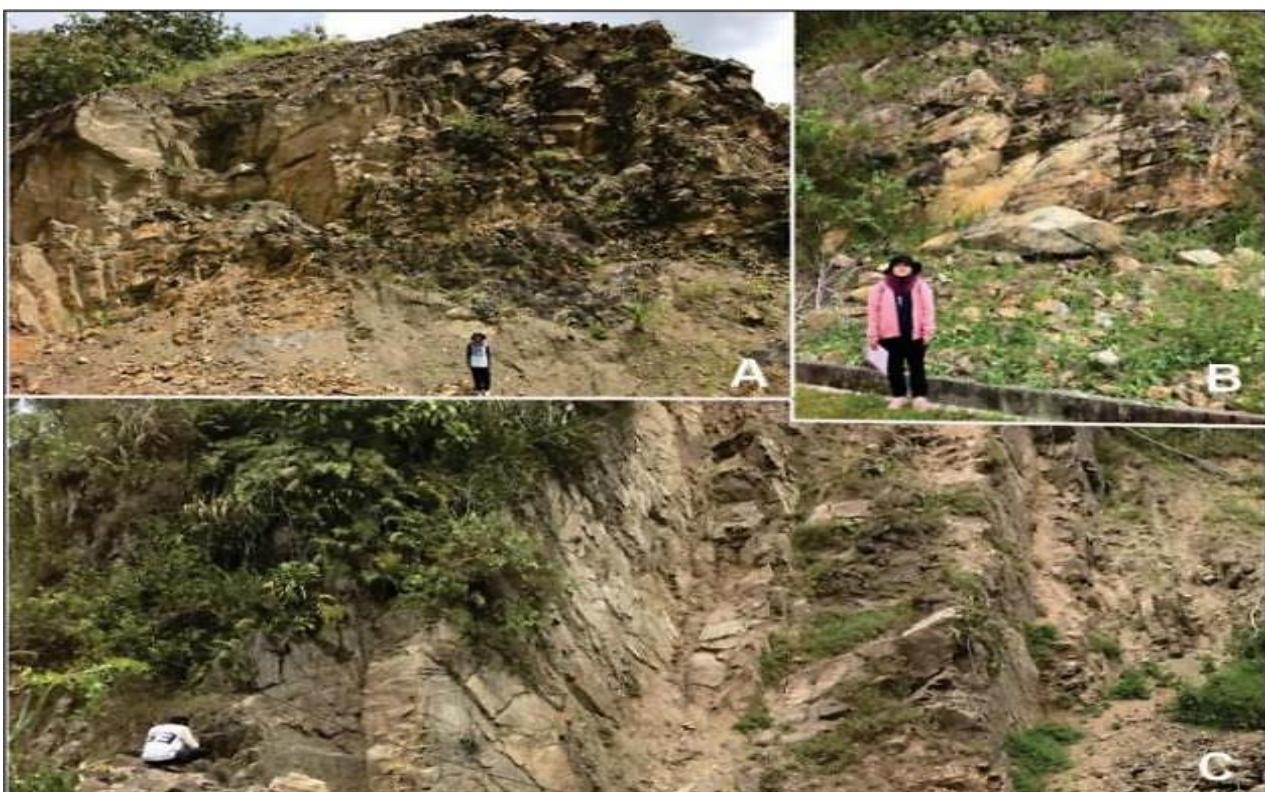
Field observation shows that the rock unit was highly jointed and sheared (Photo 2). The discontinuities are varied from four (4) to six (6) sets. Some are individually and some are intersected with other sets to 'daylight' on slope face to form planar, toppling, and/ or wedge types of mode of rock slope failures. These show that the occurrence of joint and shear planes has naturally caused landslides by decreasing resisting force for slope-forming rock materials.

Photo 2 Fractured and sheared meta-sandstone of Trusmadi formation forming the wedge failures, toppling failure, and rock fall (A-C).

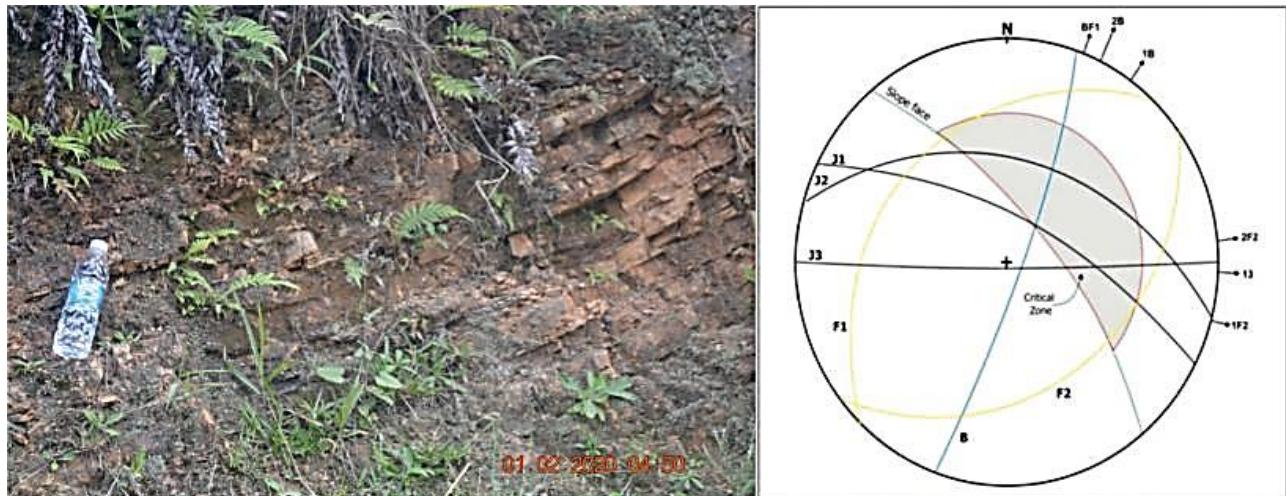
Adversely oriented discontinuities (bedding) or structural (fault) discontinuity with slope face have been observed in the study area. The first example is shown in Figure 8. This Trusmadi formation was cut by six (6) discontinuity sets including joint, bedding, and fault planes. The intersection of joint 1 (J1) and bedding (B) planes was 'daylight' on slope face or contributed to 'unfavourable' discontinuity orientation. This was causing the formation of potential wedge failure. This indicates that adversely oriented discontinuities are a naturally causal factor for landslides.

Figure 8 Trusmadi formation's outcrop and wedge failure from Markland test representing adverse discontinuity orientation with slope face.

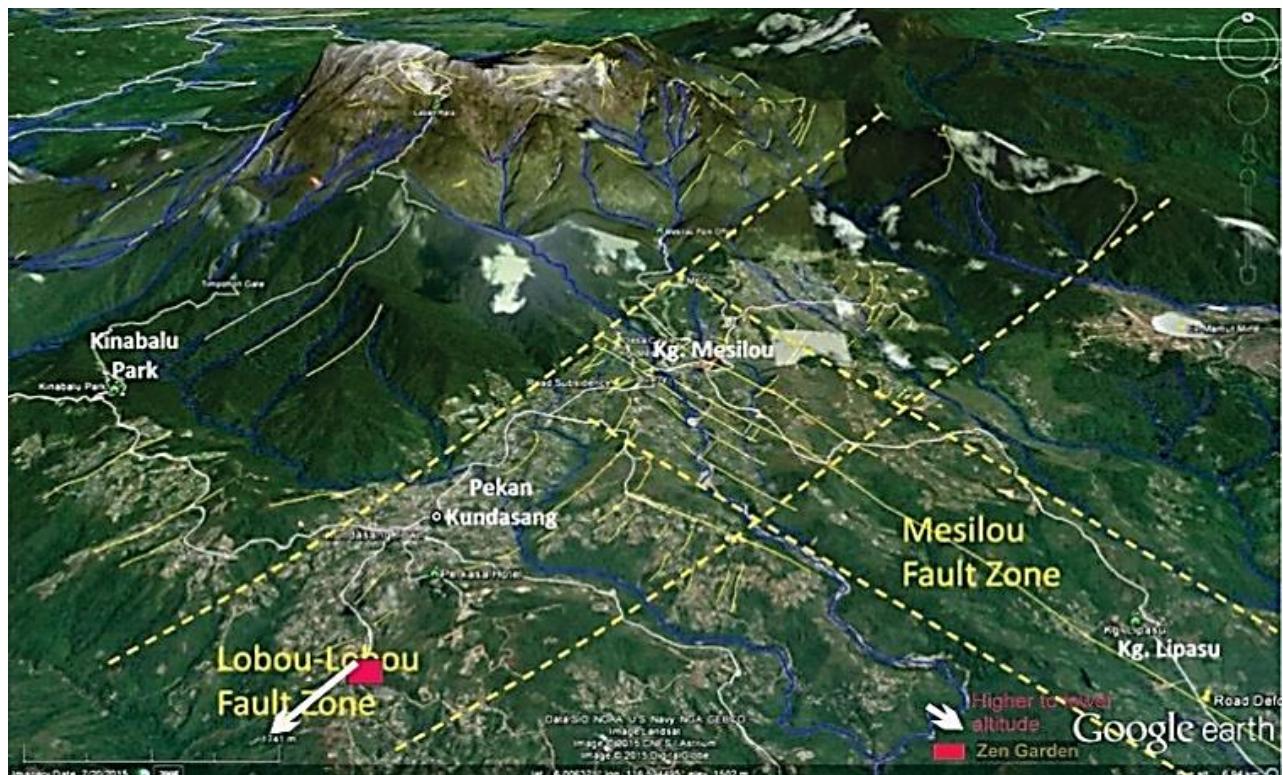
In general, the Kundasang area is situated at the intersection of major fault zones of the Quaternary ages as highlighted in Tjia (2007) (Figure 9). The study area is situated inside the northern part of Crocker Faults Zone, CFZ which is known as an oblique normal fault of Lobou-Lobou Fault Zone (LFZ). The slope face is facing the lower altitude of sg. Kayongang valley in LFZ and the movement of this fault has broken and fractured the bedrock along the fault line and slope toe (JMGM, 2012). This condition has been reducing toe support and shear strength (resisting force) but raising the driving force (plus the weight or gravity) of the slope forming rock material, especially during rainy days. Then, the adverse orientation of structural discontinuity has been causing a landslide-prone condition in the study area.

Figure 9 Normal fault scarp (in yellow) trending NE-SW across the Kundasang- Mesilou areas. These faults are grouped under the Lobou-Lobou Fault Zone. White arrows show driving force direction). Adapted from Ismail Abd Rahim et al. (2015).

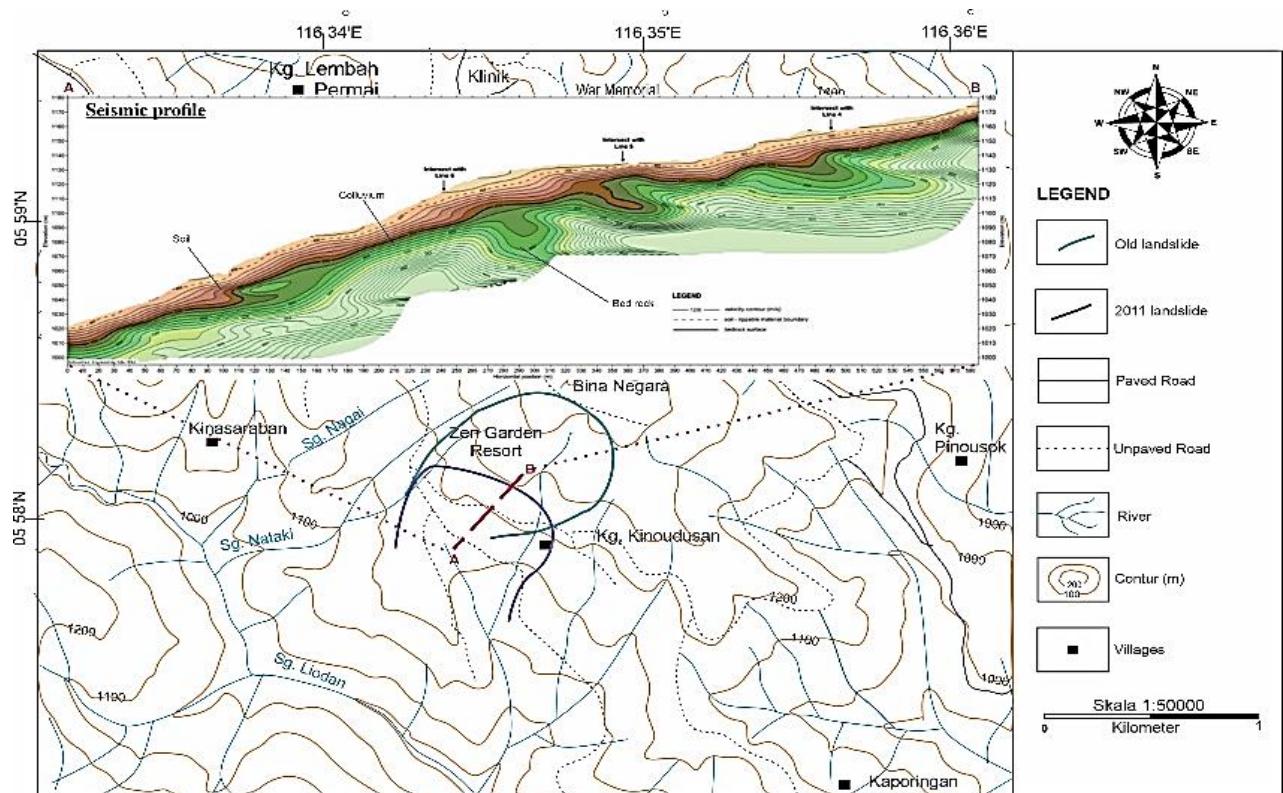
The thickness of Colluvium in the studied slope varies from 10-20m (Figure 10). The rainfall intensity during that event is only 1.54 mm/hr. which is far from the suggested values (rainfall intensity of 3 to 4 mm/hr.) for the formation of a perched water table. But the daily rainfall ranges from 0.5 to 4.85 mm/hr. for several days before the event may cause the water to percolate into colluvium and exceed the rate of seeping into bedrock. This condition forms a temporary perched water table in the Colluvium, and a downslope seepage force develops within the Colluvium. Excess pore pressures develop, the Colluvium becomes buoyant, the resisting forces are decreased, and landslides will occur (Turner, 1996; Kesseli, 1943).

Permeability contrasts within the bedrock may result in artesian conditions (Turner & Schuster, 1996). The water contains Colluvium (dark brown) and bedrock units (dark green), and artesian (dark brown greenish color) conditions are shown in Figure 10.

This artesian condition was causing the water flow to concentrate within the Colluvium by the differences in permeability within both the Colluvium and the bedrock (Ellen, 1988) and facilitated landslides to occur.

The seismic profile in Figure 10 also shows the thin Colluvium deposit and high-water table of less than 20m depth. This high-water table will allow fast saturation conditions and reactivation or/ and creation of sliding plane, sliding process or landslide.

Figure 10 Seismic profile showing bed rock (Trusmadi formation), colluvium and soil. The 10-20m thick colluvium deposit can reach field capacity condition and perched water table. The dark brown and green show the contrast in permeability between colluvium deposit and

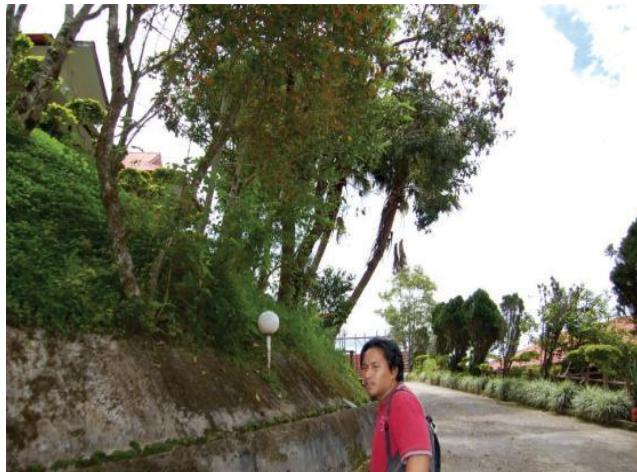
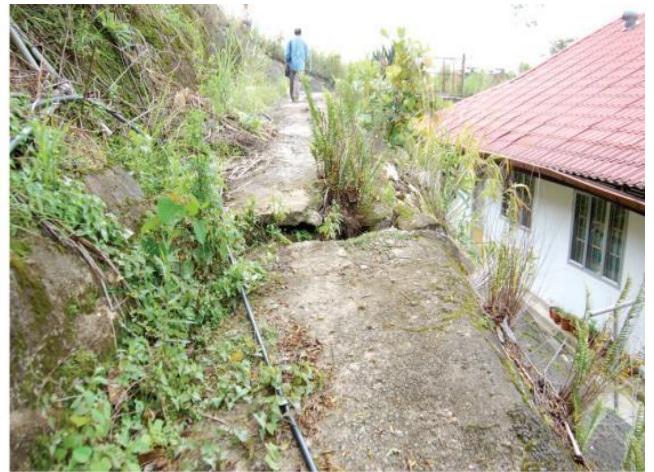
The purpose of excavating the slope and slope toe is to stabilize and protect slopes as well as provide accessibility. The slope face is normally excavated for optimum slope angle, to reduce erosion, infiltration, and weathering rates, and to control surface water (Photo 3). But improper excavation will result in causing slope failures. Such as inaccurate optimum slope angle, improper berm drains, infiltration, and surface water controls.

Photo 3 Slope excavations. Construction of optimum slope angle, terrace, berm drain and shotcrete to increase resisting forces.

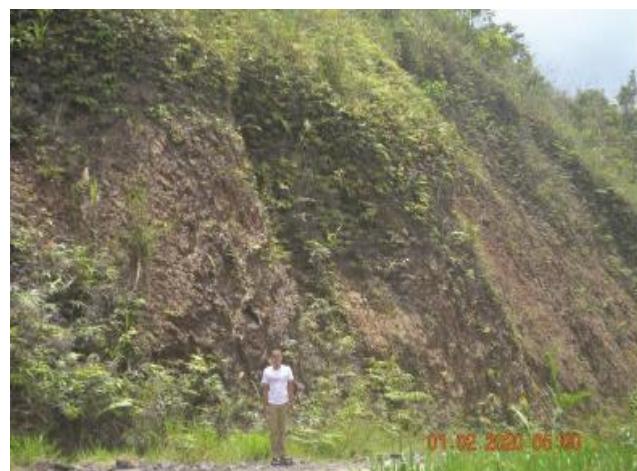
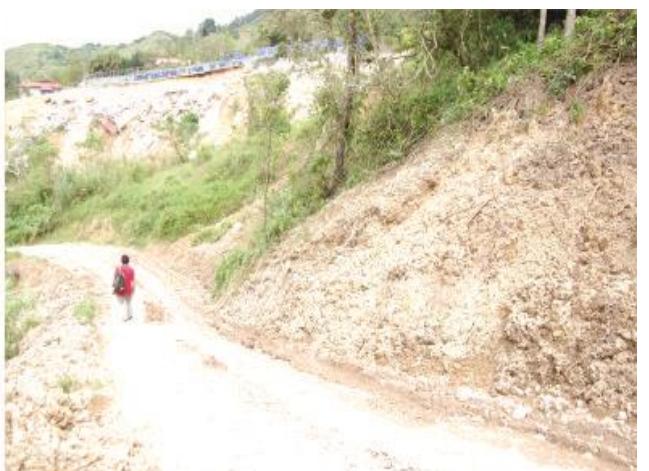
Slope toe excavation was conducted to provide facilities for the resort itself or local residence surroundings (Photo 4). But improper excavation on slope toe has caused slope failure due to loss of or reduction of resisting force for slope forming materials.

Photo 4 Construction of minor roads at slope toe for the accessibility of the surrounding residents.

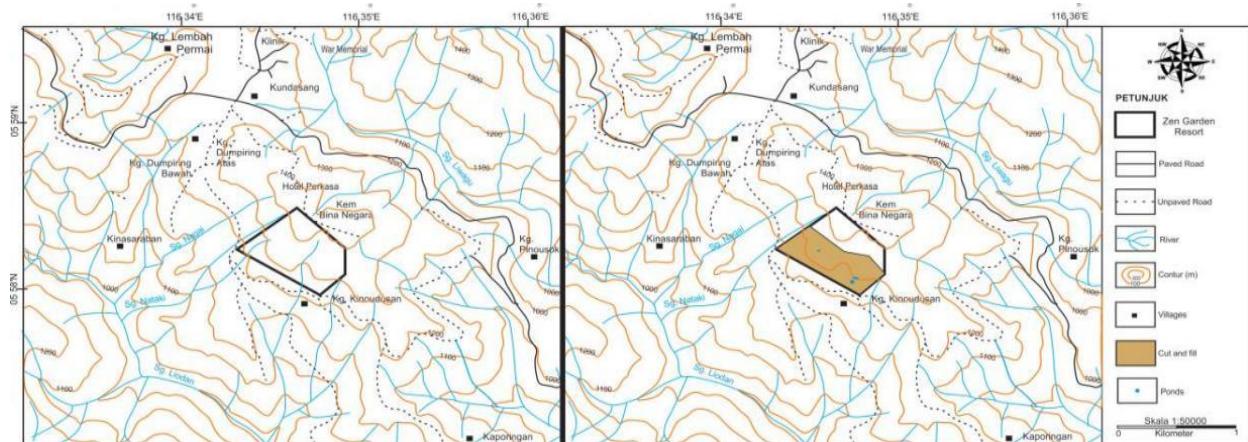
There are about two square kilometers have been cut and filled to design and build the facilities in Zen Garden Resort (Figure 11). The cut and fill materials on the original ridge topography area may also contribute to weakening the ground foundation in a long-term condition since water flow, soil, and rock condition were already disturbed and altered. These activities altered the slope faces and drainage patterns in that area. The slope cutting has risen the rate of weathering, erosion, and infiltration. These in turn were reducing the resisting force of the slope.

Figure 11 Zen Garden Resort landslide area and cut and fill section. Some rivers were filled and altered for this development.

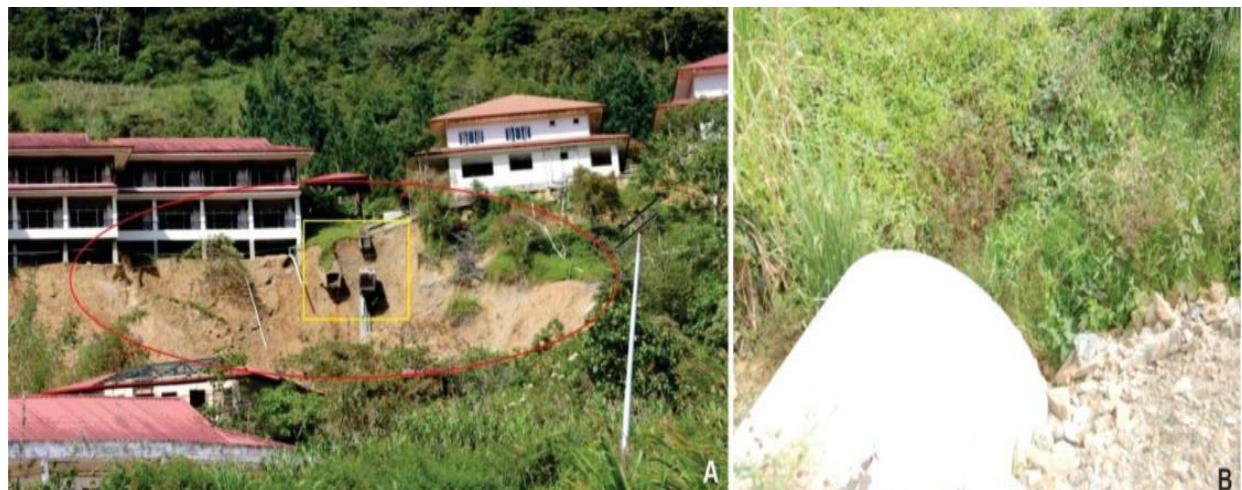
Photo 5 A- Evidence of old drainage channel and landslide which has been cut (for foundation and building) and filled (red circle) and alteration of natural drainage by the construction of concrete drainage (yellow square). B- filling activity and changing natural drainage channel into the culvert.

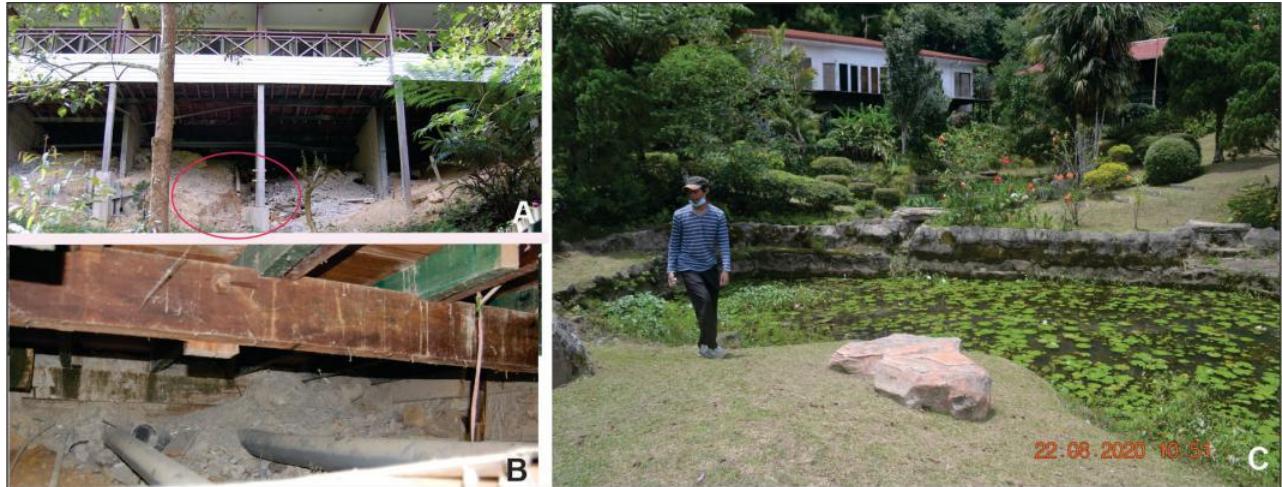
Subterranean drainage is a subsurface drainage system which is not seen from the surface. Normally subterranean drainage is made of PVC (Photo 6B) in various sizes or constructed of concrete (Photograph 6C). There is no landslide issue if this subterranean drainage is working. The problem is if the channel break or leakage (Photo 6A) then, subterranean erosion will occur. This leakage will erode the slope forming rock materials and finally reduce the resisting force.

Photo 6 Subterranean erosion. A- water leakage (red circle) due to broken channel or connection failure: B- subterranean drain (PVC) that is connected to the river; C- a small pond that is connected by the subsurface concrete drain. This pond is believed to be a small old river channel that fills and alters into a subterranean concrete ditch.

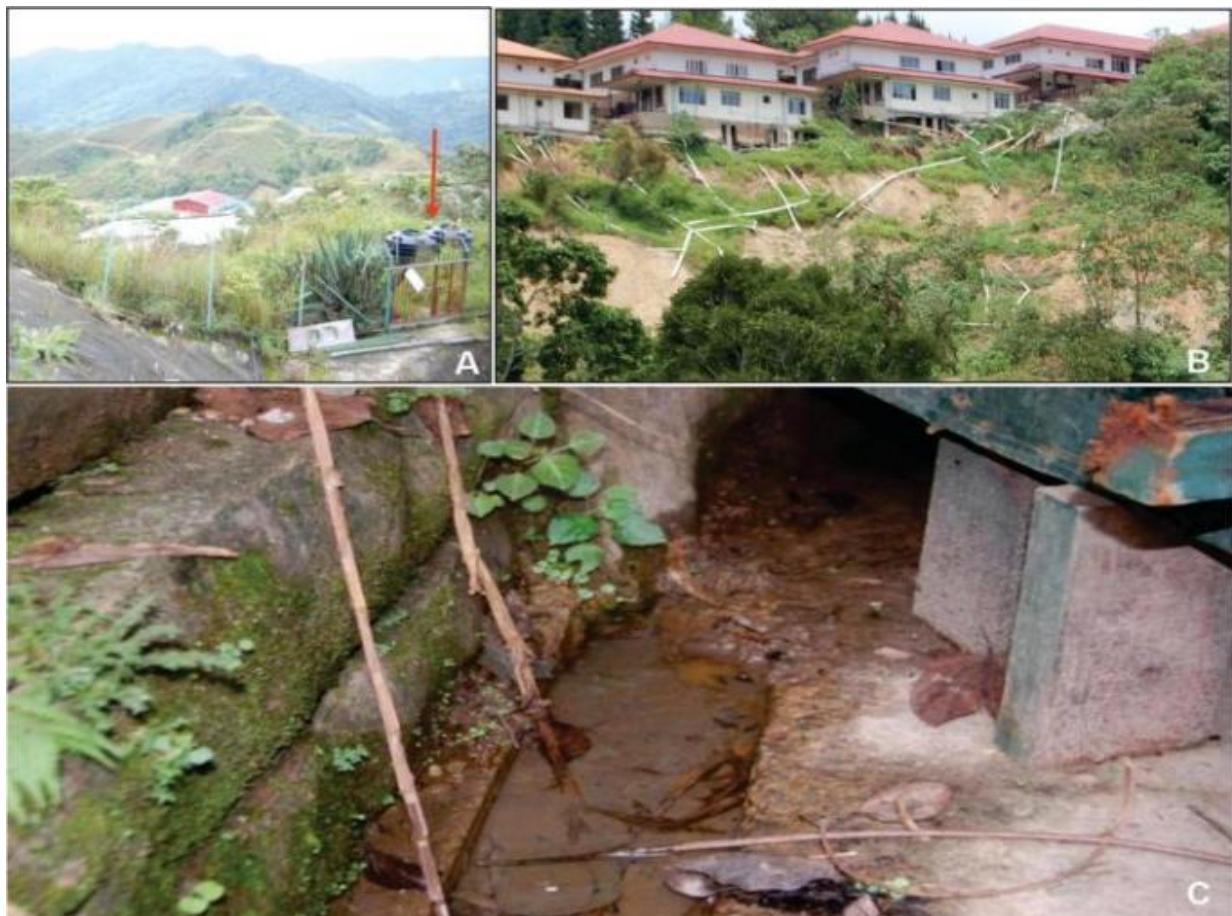
Kundasang is a highland area and doesn't have a proper water supply station except for collected from the natural spring water by Sabah Drainage and Irrigation Department, JPS. The activities or operation in Zen Garden Resort was conducted by using the water supply from JPS and collecting rainwater from Resort's personal tank. The photograph below shows the Resort water tank (in black color, Photo 7A) and irrigation system (Photo 7B)

The landslides become an issue if there is leakage in the tank and irrigation networks. This leakage will behave like rainwater that decreases the resisting force of rock-forming slope materials. The same condition will happen if a concrete ditch leaks by the occurrence of faults (Photo 7C).

Photo 7 Water leakage from utilities. A- water tank to reserve water supply; B- part of irrigation or drainage system around this Resort; C- concrete ditch filled with water shows a fault (?) form fracture.

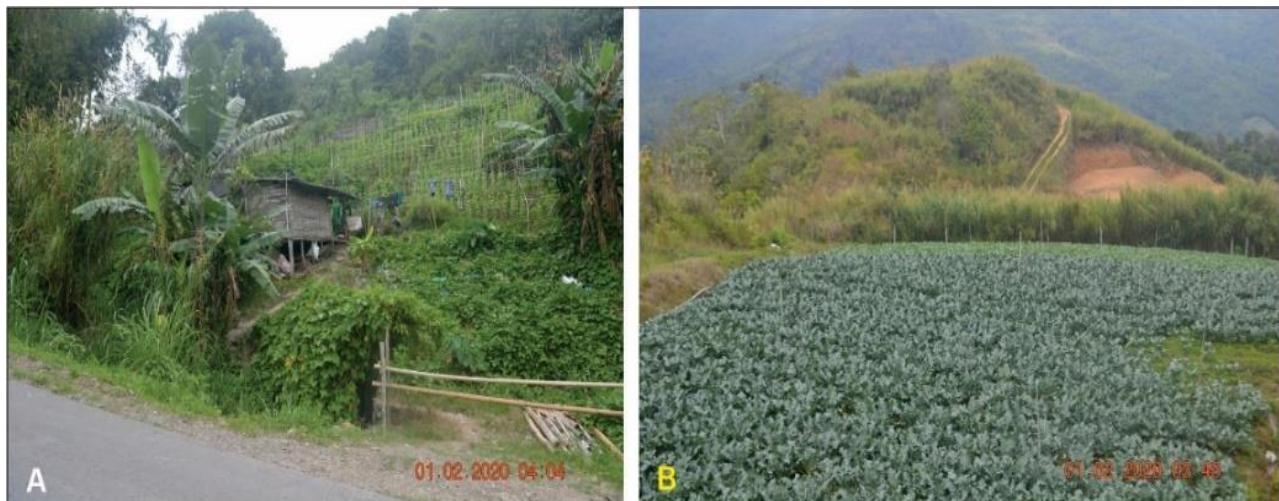
Agricultural activity is still can be seen today (Photo 8). The land clearance has been causing the rate of erosion, weathering, and infiltration (runoff) to increase but reducing resisting force for slope forming rock material and contributing to landslides occurrence.

Photo 8 Vegetation removal or deforestation and planting activity by the locals.
