# Effect of artificial structures on shoreline profile of Selingan Island, Sandakan, Sabah, Malaysia

Selingan Island off Sandakan, Sabah is a famous turtle nesting ground and a part of the Turtle Islands Park (TIP) within the Coral Triangle region of Malaysia. This small island faces the serious problem of beach erosion that is reducing the turtle nesting area. Sabah Parks deployed stone revetments in 2005, followed by placement of reef balls at the southern part of the Selingan Island in 2007 for protecting the shoreline. The objective of this study was to determine the effectiveness of these measures for shoreline protection. Shoreline changes were determined from satellite images, beach profiling and field observations. Satellite images from 2010 to 2016 were obtained from Google Earth Pro analyzed to examine the changes in the shape and size of the island with QGIS software. Beach profiling was performed in December 2017 at three sites and compared with the condition in 2011. The findings indicated that the shape of the island was squeezed towards the east where the reef balls were located. The size of the island has not changed much in 9 years after the deployment of the reef

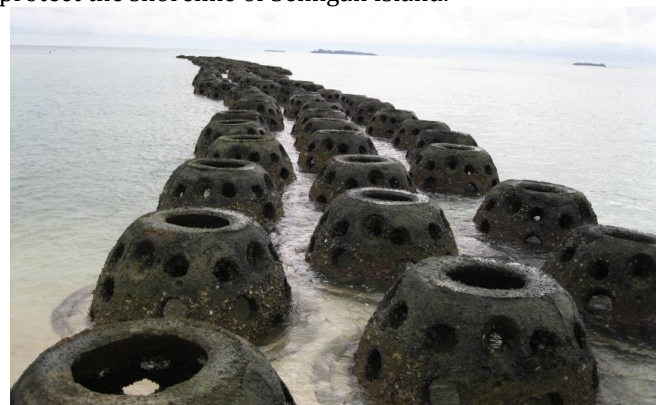
The erosional problem has caused loss of both habitat and infrastructure on the Selingan Island. Jetty, public toilet and part of Sabah Park's office were damaged due to beach erosion. As a solution, Sabah Parks and Reef Ball Foundation collaborated to install about 290 sets of reef balls (Goliath balls) (Figure 1) as shoreline protection at the southern part of the island in 2007, which was severely affected by the erosion. This is an extension of the stone revetment installed parallel to the shoreline in 2005. The reef balls were deployed by arranging into three rows to increase the stability. Those reef balls serve as submerged breakwaters to protect the shoreline of Selingan Island.

Figure 1. Reef Balls at Selingan Island.

Reef balls help in stabilizing the shoreline through wave attenuation and refraction. Deployment can take the form of three segmented breakwater sections by three rows of Reef Ball™ units for each segment (Harris, 2003). Reef balls imitate natural system which has holes of varying size. The holes in the interior cavity are smaller than the exterior to create a whirlpool effect to nourish marine life attached to the reef. All surfaces can be enhanced with air entrainment admixture to produce small pockets in the concrete which allow tiny marine organisms a place to attach themselves (Reef Ball Foundation, 2017). Reef balls have been deployed in many countries including Israel, Egypt and USA to protect their coastal areas (Harris, 2009).

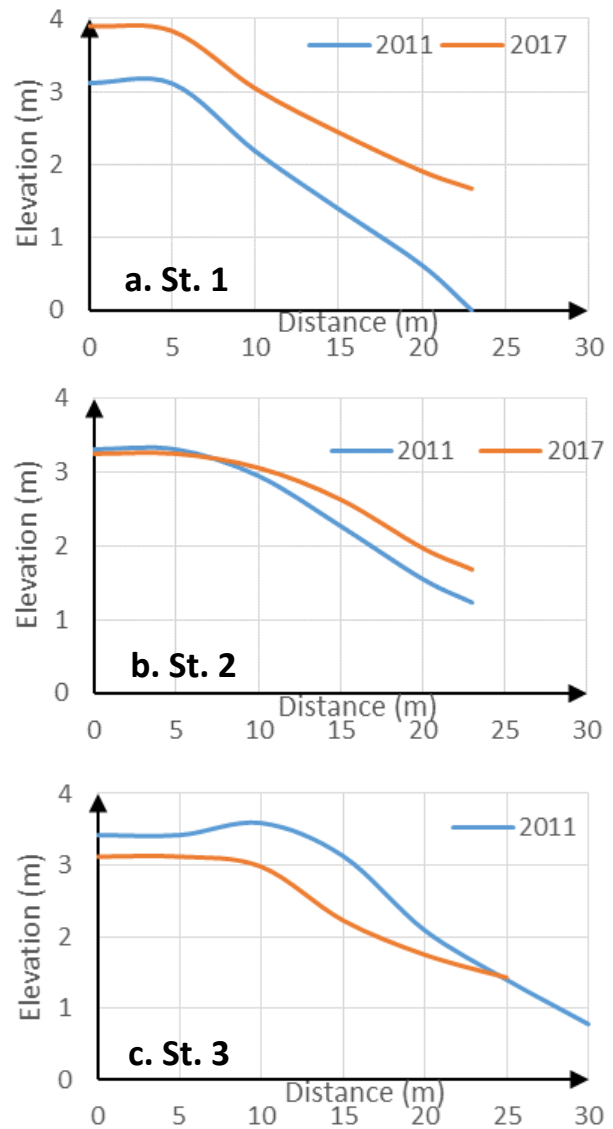
Beach profiles at St. 1 showed high beach elevation in 2017 compared to 2011, from the reference point to the low tide. However, there was no change in the width of the beach (~ 23 m) (Figure 6a). There was not much change at high tide (St 2) area but elevation was high in 2017 compared to 2011 at mid to low tides area (Figure 6b). Both beach profiles for St. 3 showed slight changes in elevation from 5 m to 10 m distances from the reference point (Figure 6c). Steep gradient was seen at 10 m in both years. The beach has a higher elevation in 2011 compared to the beach profile in 2017.

**Figure 6.** Comparison of beach profiles at three different stations (Stations 1, 2 and 3) in Selingan Island from 2011 and 2017.

The beach elevation at the east side of the Selingan Island (St. 1) is higher and created a steep profile in 2017 (Figure 6a). Based on the satellite images (Figure 5), the land area around St 1 decreased from 2011 to 2017. The beach profiling was conducted during the northeast monsoon period when the wind blows easterly or northeasterly, and this might result in moving the sediments from offshore and its deposition on the beach towards the eastern side of the island. The beach elevation in 2017 is higher and steeper but may reduce at the end of this season.

Seasonal monsoon promotes sand deposition at low tide area in St 2 (Figure 6b). During the field trip in 2011, it was also observed that around 80 units of reef balls from the west to the middle of these structures were covered with sand (Figure 7a). The performance of the reef balls in shoreline protection depends on the incoming wave energy. If the wave energy is low, reef balls might slow down the waves and allow sand to be deposited on these structured or nearby (Harris, 2001). This might explain the condition of the shoreline in 2012, 2014 and field observation in 2011.

The beach elevation in St 3 is higher in 2011 compared to 2017 (Figure 5c). This station had the steepest slope compared to the other two stations. Presence of large coral reef area in front of St 3 serves as a natural shoreline protection and is able to attenuate incoming wave energy and reduce the rate of erosion (Elliff and Silva, 2017 and Maza *et al.*, 2016).

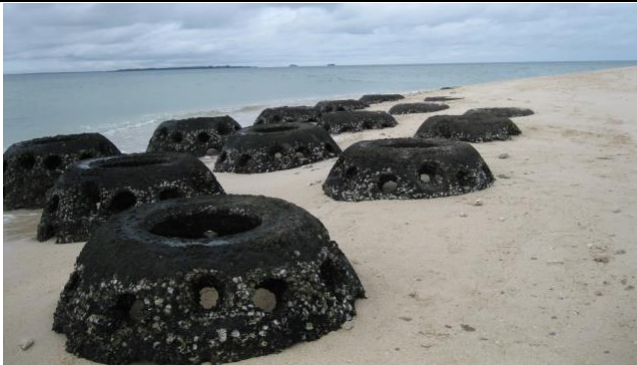
A comparison of the field observations of the Selingan Island’s shoreline in 2011 and 2017 (Figure 7) yielded interesting information. The sand accumulated at the southern end was seen to have shifted and covered part of the reef balls in 2011 (Figure 7a). The satellite images showed that reef balls were also connected to the Island between 2012 and 2014 (Figures 3-4). Part of the Sabah Parks office structures was damaged by strong waves in 2005 and can still be seen in 2011 (Figure 7b). There is also an accumulation of sand between the stone revetment and Island. Creeping vegetation and coconuts trees planted by the Sabah Parks staff were growing parallel to the stone revetments (Figure 7c). The vegetable looked healthy.

**a.** Some reef balls were covered by sand.

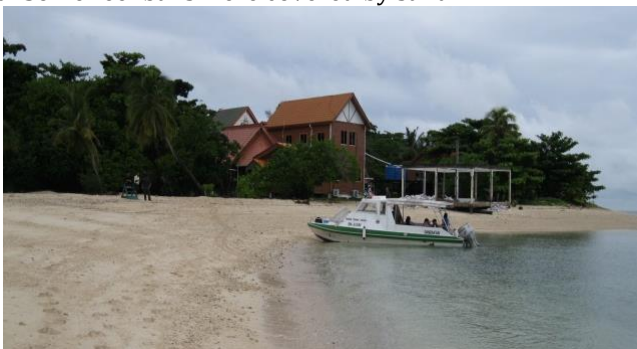
**b.** Exposed beach and part of the Sabah Parks office. Some damage to the building by strong waves was noticeable.

Before the shoreline protection measures were taken, the southern part of Selingan Island suffered from severe beach erosion and part of the Sabah Parks office building was damaged by strong waves (Figure 7b and Figure 8a) as explained earlier. Therefore, installation of reef balls as additional shoreline protection in 2007 was approved by the State Government (Figure 8b). The situation of the shoreline has improved over the years. There is no formation of tombolo on the eastern side of the Island and more sediments are deposited on the southern tip of Selingan in 2016 (Figure 8c). During the field observation in 2017, the upper part of this beach was covered by coastal vegetation (Figure 7e) and the area is used by the turtles as the nesting ground. This indicates that the reef balls have successfully increased the sand deposition processes in the south of the Selingan Island. The success of reef balls in shoreline protection as seen in Selingan Island has also been reported elsewhere (Iskander, 2010; Harris, 2006; Harris, 2007 and Arnouil, 2008).

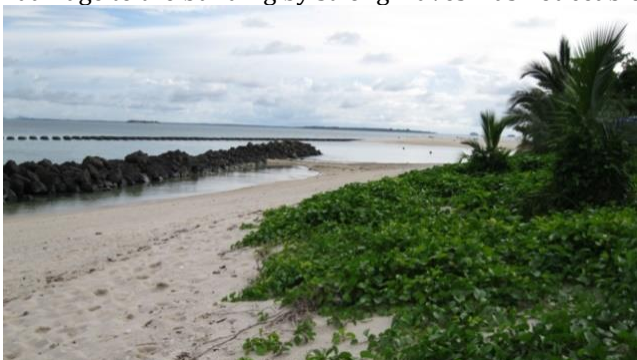
**c.** Healthy vegetation and coconuts tree growing parallel to the stone revetments.

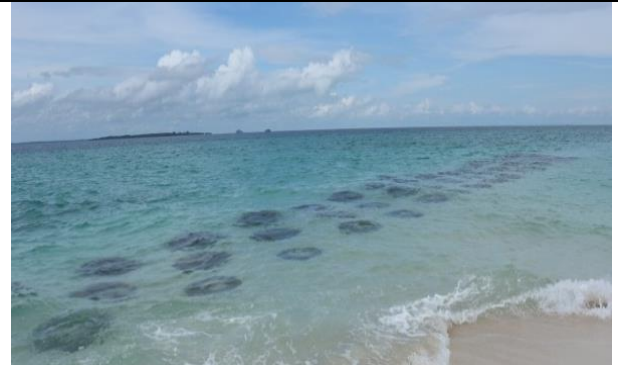
**d.** All reef balls are exposed during low tide.

All the reef balls covered by sand in 2011 were exposed in 2017 (Figure 7d). The sand in this area shifted further to the southeastern side between the reef balls and the Island. Sand was also deposited next to the Sabah Parks office (Figure 7e). Creeping vegetation was also growing on the sand with marking of turtle nesting activity. The sand next to the coconuts tree showed signs of turtle activities which caused reduction of the vegetation coverage (Figure 7f).

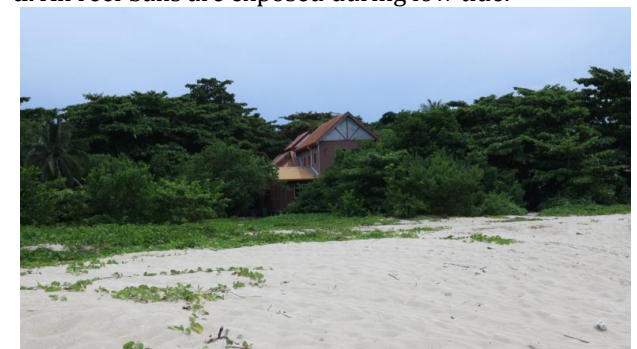
**e.** More trees and creeping vegetation surrounding the Sabah Parks office.

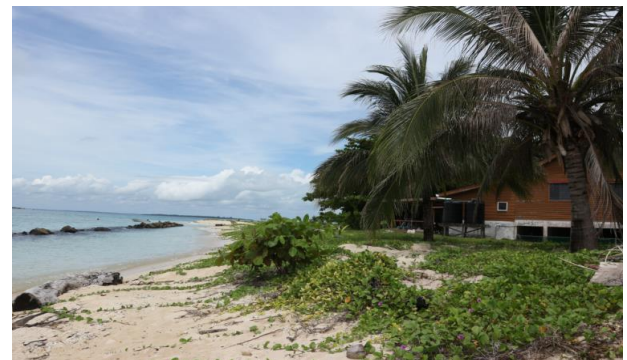
**f.** Turtle nesting activities have reduced the vegetation cover.

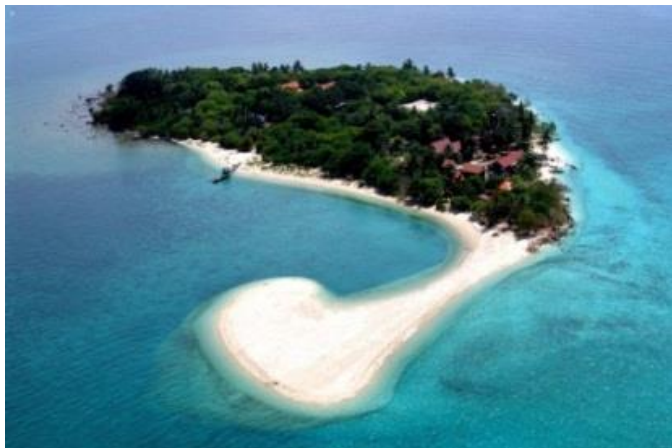
a. Formation of spilt at the southern part of Selingan Island before the shoreline protection.

**Figure 8.** Selingan Island before (a) and after (b-c) the shoreline protection measures.

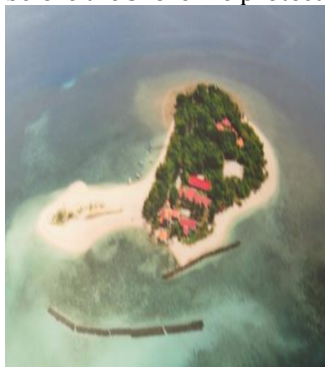
b. Two shorelines protection measures were taken to reduce beach erosion in 2006.

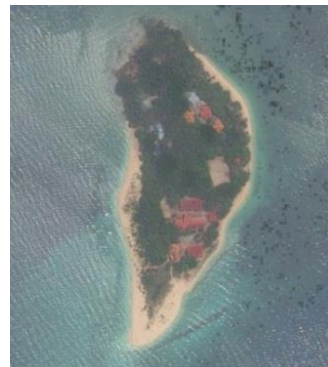
c. Spilt has disappeared and sand accumulated at southern end between the shoreline protection and the Island.

The sand deposition process in Selingan Island may relate to the attenuation of waves and reduction of local current speed around it. The waves break up upon coming into contact with the reef balls and this reduces the wave energy as the water approaches the shore which in turn curtails the erosional influence of water strike (Harris, 2009). When waves hit the reef balls and enter into shallow water, the wave angles are refracted and tend to become parallel to the shoreline. According to Mead and Black (2002), the waters that travel across the shallow submerged breakwater are wide enough to reduce magnitude of longshore currents and wave transport which then reduce the erosion of an area. The presence of reef balls helps in stabilizing the coast by wave attenuation and wave refraction.
