CASE REPORT

Dental Aesthetics and Functional Rehabilitation in a Case of Reinfection and Tooth Loss: A Case Report

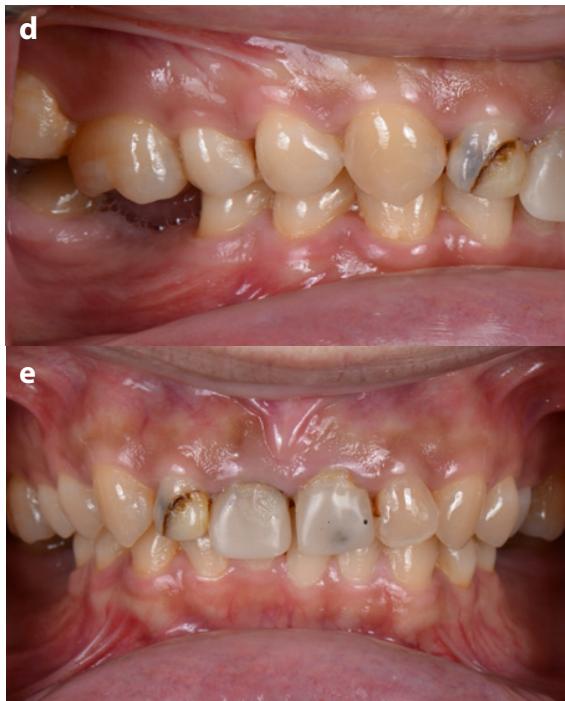
On clinical examination, the patient was found to be partially edentulous in the lower arch, with multiple heavily restored teeth and missing bilateral mandibular first molars (Figure 1). Teeth 11 and 21 were restored with composite and metal posts, both of which had developed secondary caries under the composite (Figure 2). These teeth were also tender to percussion and palpation.

Figure 1: Intraoperative pre-operative pictures. a) maxillary arch b) mandibular arch c) right buccal view d) left buccal view e) frontal view

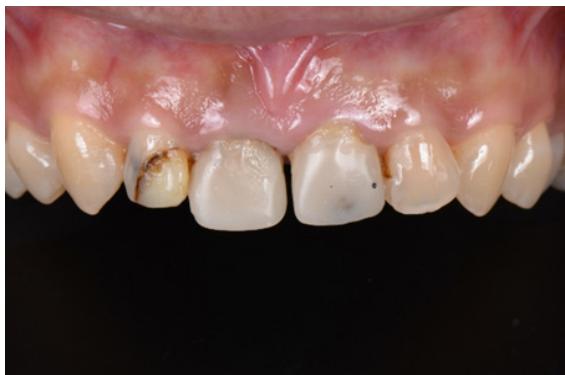
Figure 2: Area of presenting complaint

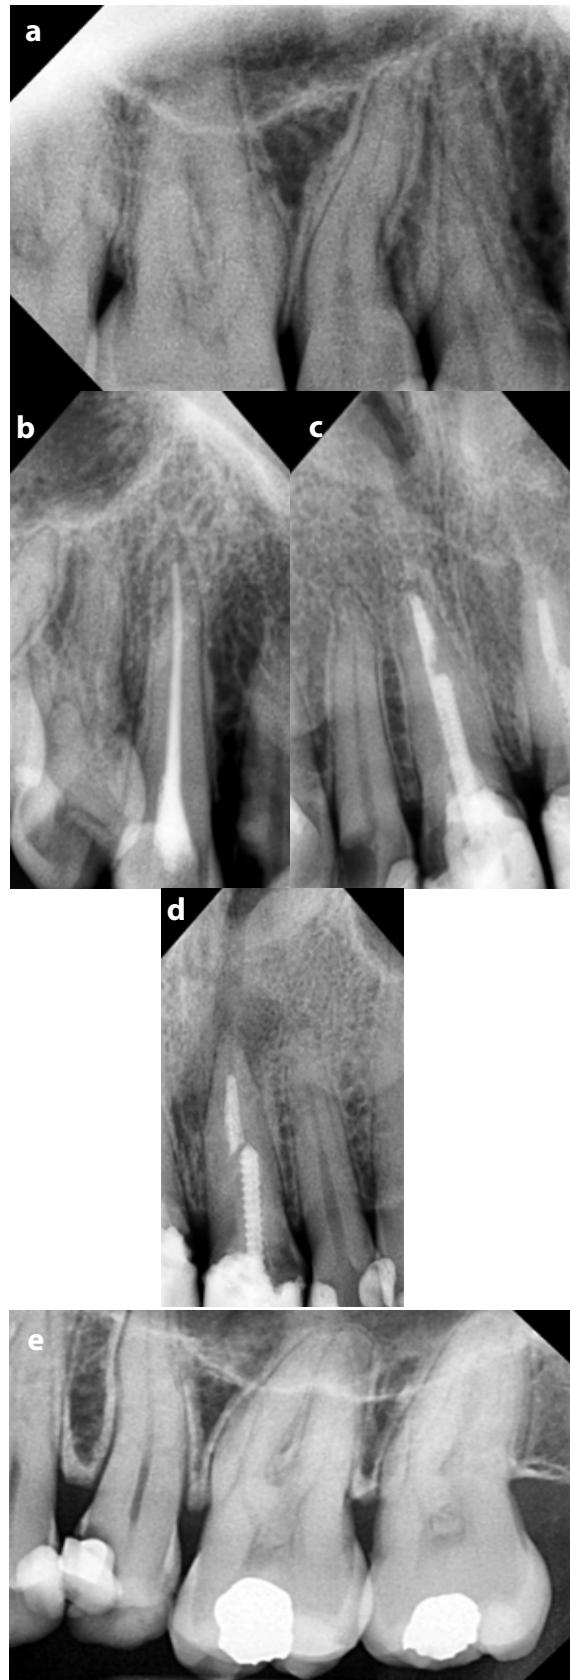
periapical radiolucency at the root of tooth 21, suggesting a chronic infection. Radiolucencies were also observed on adjacent teeth (12, 22, and 25), indicative of secondary caries (Figure 3). Teeth 13, 11, and 21 was root treated.

Figure 3: Periapical radiograph. a) teeth 16-15 b) teeth 14-13 c) teeth 12-11 d) teeth 21-22 e) teeth 23-27

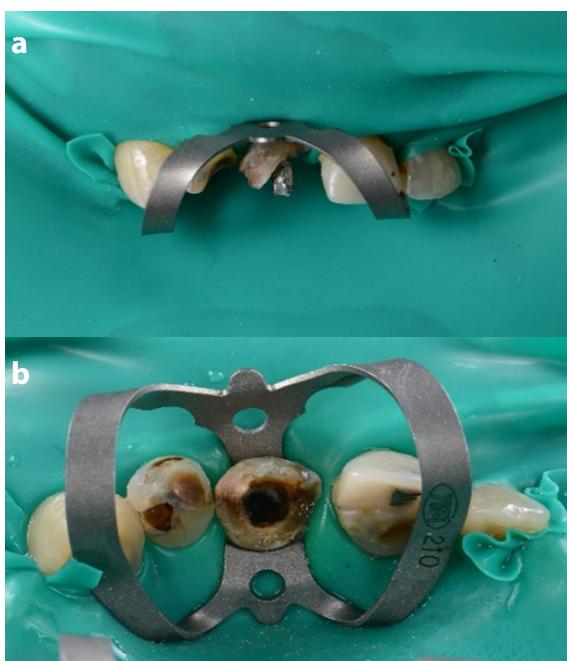
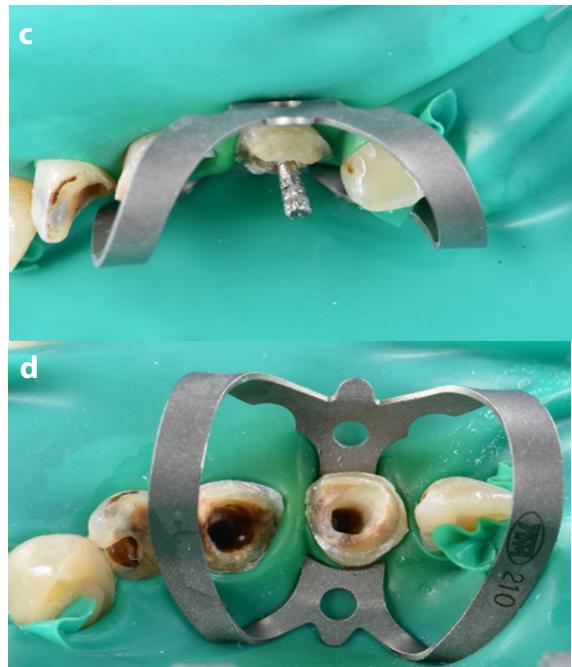
After removing the existing restorations and metal posts on teeth 11 and 21, secondary caries were detected and removed. A ferrule of 2 mm height and 1 mm circumference was achieved on tooth 11, and 4 mm height with 1.5 mm circumference on tooth 21, meeting the minimal structural requirements for restorability (Figure 4).

Figure 4: Access restorability a) and b) tooth 11 c) and d) tooth 21

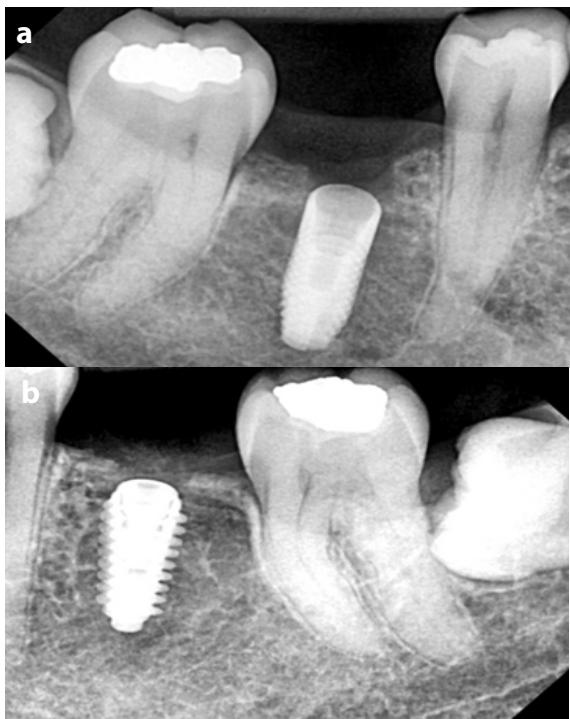
Figure 10: Periapical radiograph post-implant placement a) tooth 46 b) tooth 36

availability to support 10 mm implants (Figure 9). During surgery, a mid-crestal, full-thickness mucoperiosteal flap with a relieving incision was made. A ϕ 4.5 x 10 mm Anyridge® (Megagen, South Korea) implant was placed at

site 36 and 46, using a surgical guide (Figure 10). Cover screws were positioned post-placement, and sutures were removed after one week, with healing progressing well after four weeks. Two months post-placement, a second-stage surgery was performed to replace the cover screws with healing abutments (Figure 11).
