THE 2011 ZEN GARDEN LANDSLIDES: TRIGGER AND CAUSAL FACTORS

ABSTRACT: *The Zen Garden Resort and its surrounding area are part of the “Kundasang Landslide Complex” and were experiencing reactivation of old landslides on 10 April 2011. Consequently, more than 80 room units of the resort, ten buildings, homes, and local roads were destroyed, uplifted, and damaged as well as disrupted day traffic. About 500m in length and 200m in width of the slope area were slides for 25m. The vertical fall movement in the head section of the landslide is 25m. There is no direct relationship between the 2015 Ranau earthquake and with earlier rotational clay slide of the 2011 Zen Garden Resort landslide. The causing and triggering factor for landslides are generally varied and are always characterized as region-specific and site-specific. Thus, this study was conducted to unravel the triggering and causal factors for the rotational clay slide of the 2011 Zen Garden Resort landslide. The methodology consists of desk study, remote sensing study, geological mapping, geodynamic mapping, laboratory, and data analysis. This study found that the landslides were triggered by prolonged moderate to occasional h

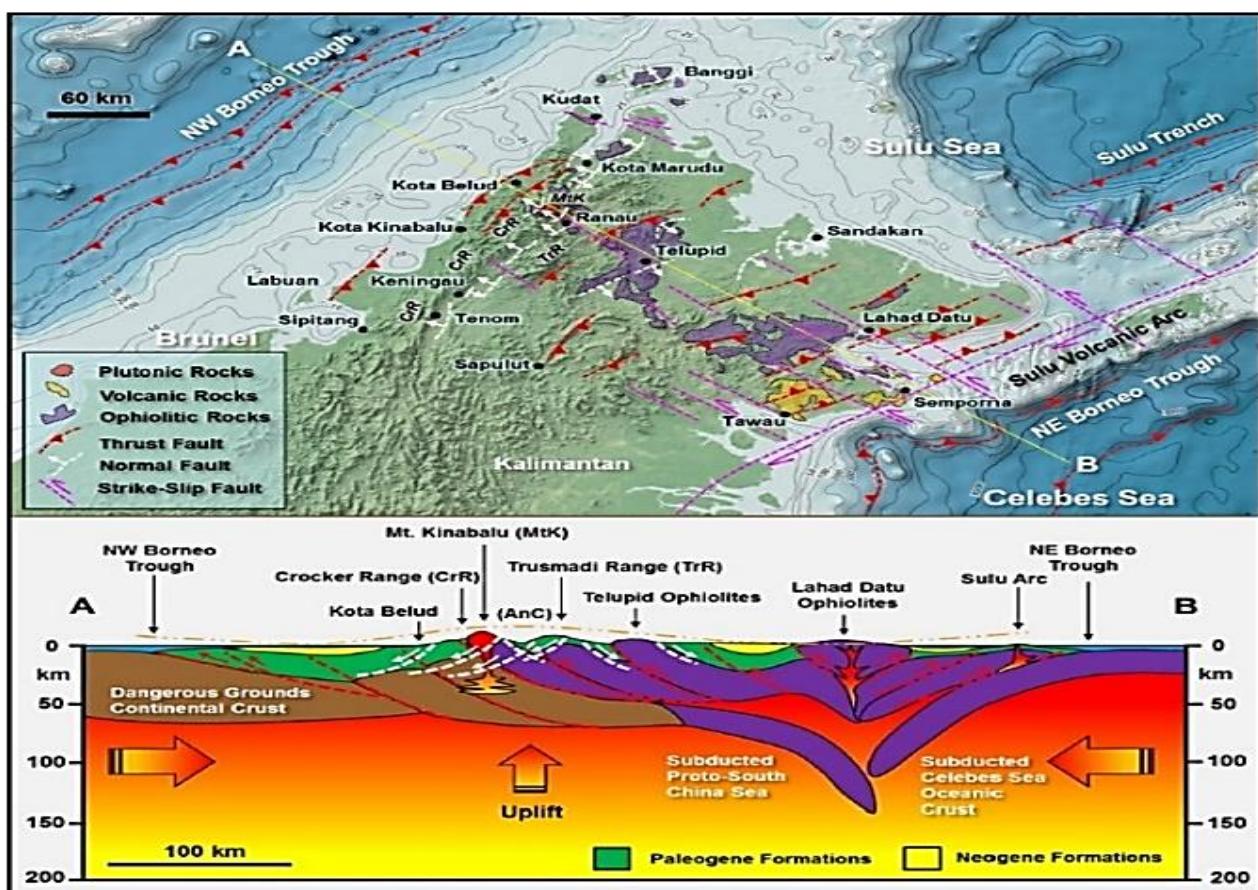
The Lobou-lobou fault zone is part of a regional extensional zone trending NW-SE along the west coast of Sabah. The NW-SE trending normal fault appears to be not directly related to the NW-SE compression but is due to gravitational sliding on an uplifted mountain belt. The uplift belt is a tectonic plate collision zone in Sabah, informally referred to as the Sabah Suture Zone (Figure 6). Continued compression in Sabah created differences of roughly around 4000 m in elevation of the upper crust - the Crocker Range is around 2000 m above sea level and the NW Borneo trough around 2000 m below sea level. As mentioned earlier, GPS readings in West Sabah indicate gravity sliding or collapsing the NW in response to significant thickening of the upper crust due to collision (Tongkul, 2015).

Figure 6 Tectonic cross-section of Sabah showing post-collision collapse due to gravity sliding producing deep-seated normal fault (white line) in response to significant thickening and uplift of the Crocker Range upper crust. A- northwest; B-southeast (adapted from Tongkul, 2015).

The uplift belt or tectonic plate collision zone is continuing to compress and produce highland areas around Crocker Range including the study area in Kundasang. This high elevation has been reducing the stability of the slopes. The higher the area, the steeper the slope and the less stable the slope. The natural tectonic uplift by collision has caused the slope to decrease in resisting force and become landslide prone.
